**Flood Control Project Maintenance
Levee Inspections**
LMA District Cover Sheet
Spring 2018 Levee Inspection Results

Reclamation District No. 0765 Glide

Spring 2018 Levee Inspection Results

Waterway			Bank	Unit Miles
Unit No. 01 Sacramento River			Right	1.72
	Spring (March - May)	Summer (June - August)	(September - November) Fall	Winter (December - February)
Unit Maintenance Rating (Fall Only)				
Date of Inspection	3/7/2018 - 3/7/2018			
DWR Inspector	Dave Torres			
Accompanied By	David Dickson RD765

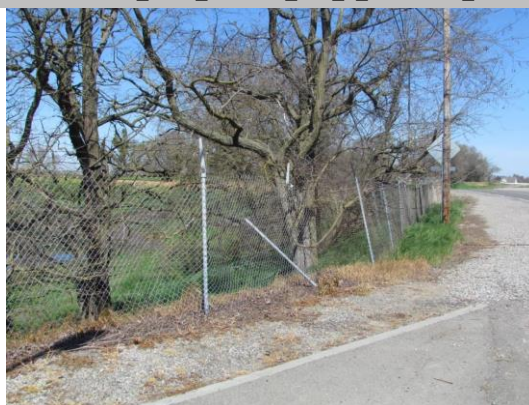
Photo 1 of 3 : SP_2018_RD0765_211_3_20180301_00003.jpg

LM Start	0.05	Rating **	U	Issue No.	3
LM End	0.05	Issue Type +	Ma	Location *	LS
Category	Earthen Levee			GPS Latitude/Longitude	
				Start	End
Item	Trim / Thin Trees			38.502253 °	38.502253 °
				-121.560192 °	-121.560192 °
DWR ID	DWR_RD0765_01_s_2012_3				
Comment Code					
T1 : Trim trees to at least five feet above ground level.					
Inspector Comment					
Trees blocking view of landside slope.

Looking north at untrimmed trees along landward slope. (Spring 2017)

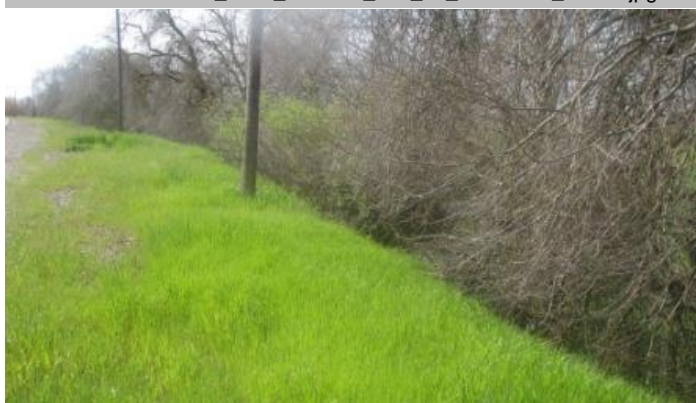
Photo 1 of 2 : SP_2018_RD0765_211_28_20180301_00031.jpg

LM Start	0.12	Rating **	M	Issue No.	28
LM End	0.25	Issue Type +	Ma	Location *	LS
Category	Earthen Levee			GPS Latitude/Longitude	
				Start	End
Item	Trim / Thin Trees			38.501215 °	38.499421 °
				-121.560432 °	-121.560471 °
DWR ID	DWR_RD0765_01_s_2012_28				
Comment Code					
T3 : Trim and thin trees to allow visibility of the ground and room to flood fight.					
Inspector Comment

Looking downstream (south) at trees on landside slope & toe.

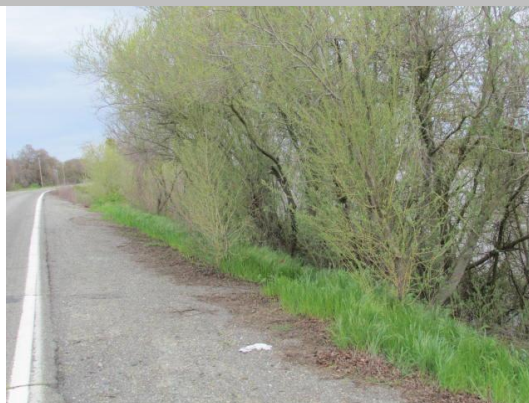
Photo 1 of 1 : SP_2018_RD0765_211_11_20180301_00015.jpg

Looking southwest at trees along landward shoulder and slope.

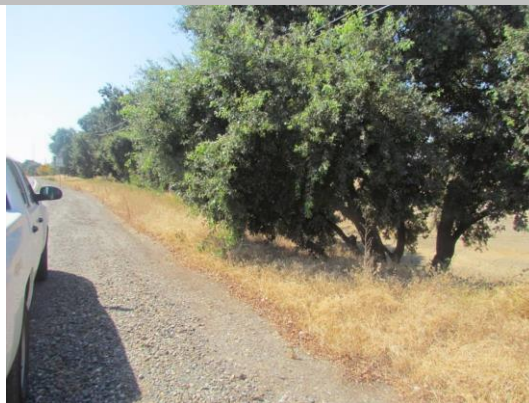
Photo 2 of 2 : SP_2018_RD0765_211_14_20180301_00020.jpg

Looking southwest at untrimmed trees on landward slope. (Fall 2016)

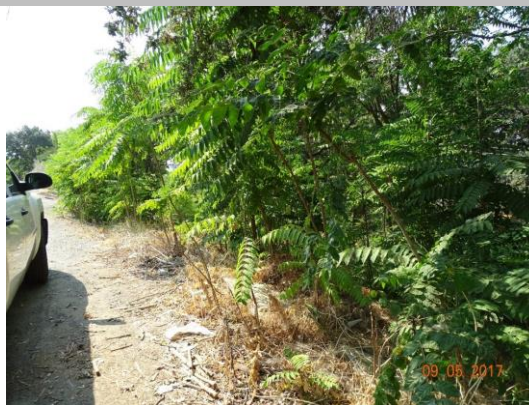
Photo 2 of 4 : SP_2018_RD0765_211_47_20180301_00050.jpg

Looking south at the landside slope (Fall 2017).

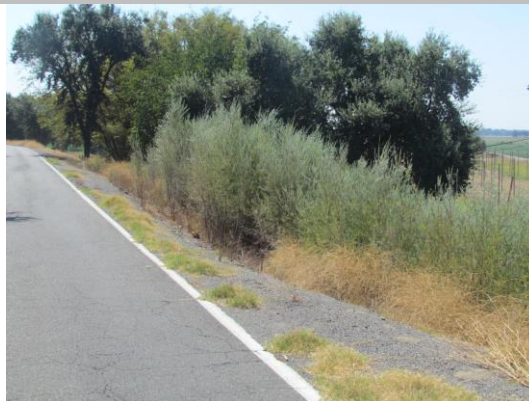
Photo 3 of 4 : SP_2018_RD0765_211_47_20180501_00097.jpg

Looking northwest at dense vegetation on landward slope. (Fall 2016)

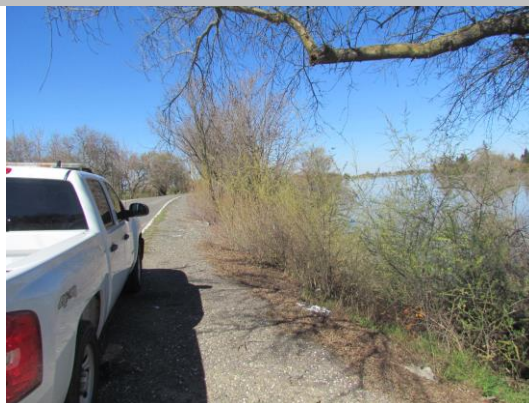
Photo 1 of 4 : SP_2018_RD0765_211_24_20180301_00025.jpg

LM Start	0.45	Rating **	U	Issue No.	24
LM End	0.47	Issue Type +	Ma	Location *	WS
Category	Earthen Levee			GPS Latitude/Longitude	
				Start	End
Item	Trim / Thin Trees			38.496534 °	38.496249 °
				-121.559880 °	-121.559760 °
DWR ID	DWR_RD0765_01_s_2012_24				
Comment Code					
T2 : Thin trees to allow visibility of the ground and room to flood fight.					
Inspector Comment					
Dense willows and untrimmed trees on waterside slope has been untrimmed for multiple inspection cycles.

Looking north at willows and other veg. on waterward slope. (Spring 2017)

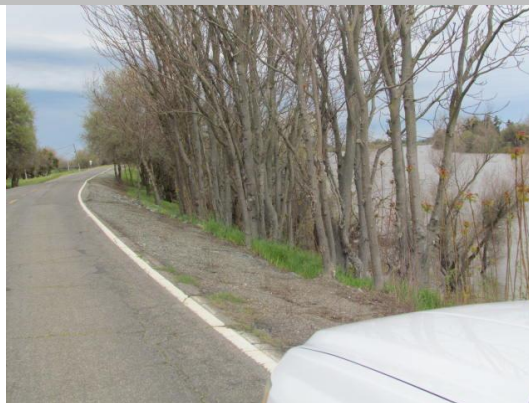
Photo 4 of 4 : SP_2018_RD0765_211_24_20180301_00028.jpg

Looking northeast at cluster of trees on waterward slope. (Spring 2016)

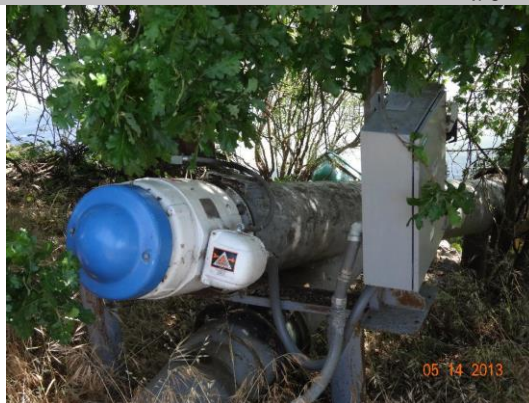
Photo 3 of 3 : UCIP_SP_2018_44403_60813.jpg

Comment Code						
Inspector Comment						
FS_ID:44403 DS_ID:21138 EP_NO: 3314 Repair Type: Non-Urgent Crossing Status: Found UCIP Comments: Dense vegetation limit's the ability to determine condition of landward slope for potential leaks associated with crossing. Recommend having owner clear slope to be able to properly inspect slopes for leaks. FIELD_STRUCT_DESC: 16-inch steel irrigation pipe through the levee, 4 feet below the crown. Cutoff wall around pipe at center of levee. Slant pump on the waterside (WS) slope, with 22-inch inlet pipe extending from channel. 16-inch pipe connects to 12-inch steel pipe at landside (LS) shoulder, extending to concrete standpipe discharge outlet at the toe. Cobble revetment on WS slope. (16-inch pipe installed and existing 16-inch pipe grouted work authorized under Permit No. 3314, 1960-C.M. Goethe) FS Date: 5/14/2013

Close up of slant pump and control panel on waterward side.

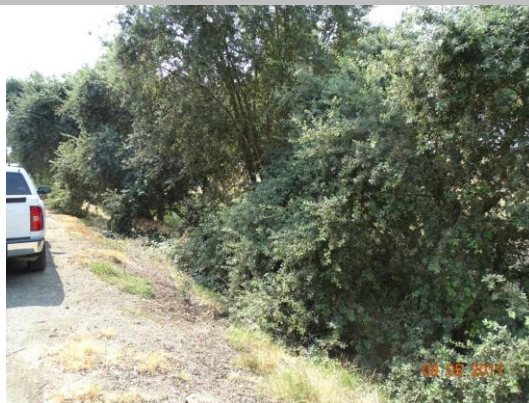
Photo 1 of 1 : SP_2018_RD0765_211_34_20180301_00043.jpg

Looking south at landside slope.

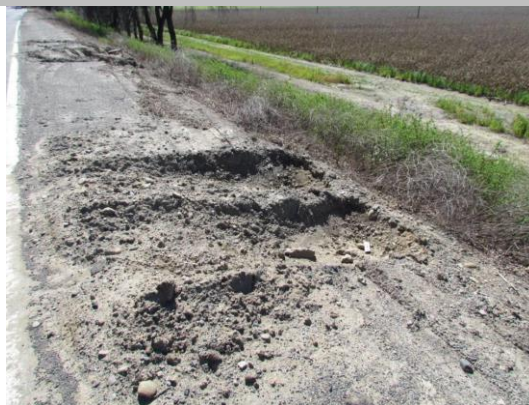
Photo 2 of 2 : SP_2018_RD0765_211_68_20180301_00079.jpg

Looking south at levee damage caused by vehicle traffic. (Spring 2017)

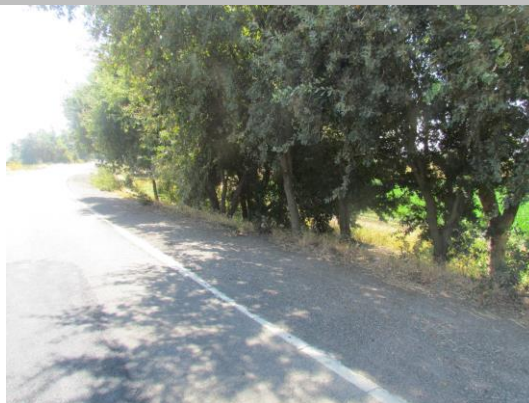
Photo 1 of 1 : SP_2018_RD0765_211_17_20180301_00021.jpg

Looking northwest at untrimmed trees on landward slope.

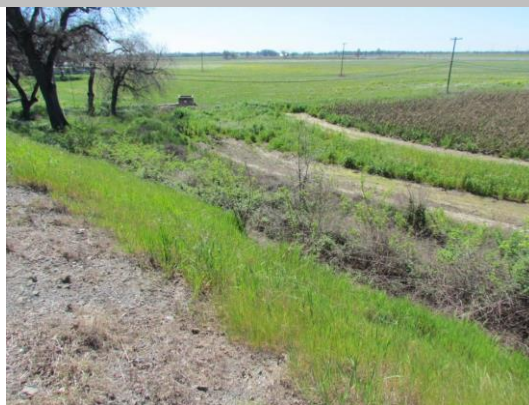
Photo 2 of 3 : SP_2018_RD0765_211_61_20180301_00073.jpg

Looking west at berryvine at bottom half of landward slope. (Spring 2017)

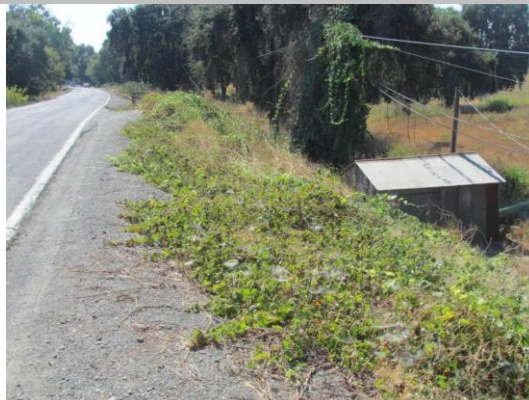
Photo 3 of 3 : SP_2018_RD0765_211_61_20180301_00074.jpg

Looking south at dense wildroses on landward slope. (Fall 2016)

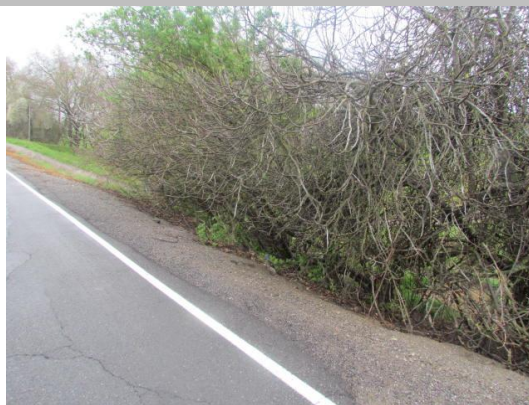
Photo 2 of 2 : SP_2018_RD0765_211_40_20180301_00048.jpg

Looking southwest at fig trees and other trees on landside slope and toe. (Fall 2016)

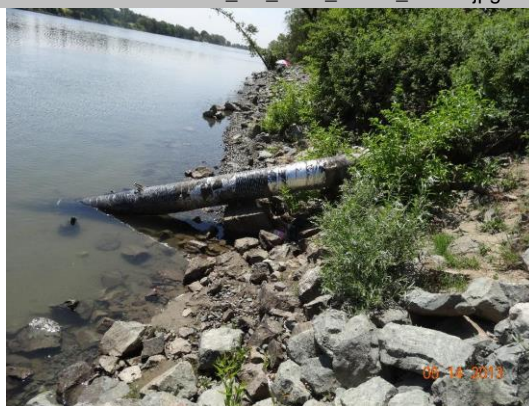
Photo 1 of 3 : UCIP_SP_2018_44404_60819.jpg

LM Start	0.95	Rating **	M	Issue No.	70
LM End	0.95	Issue Type +	En	Location *	
Category	Supplemental			GPS Latitude/Longitude	
				Start	End
Item	DWR UCIP Field Study			38.490192 °	38.490192 °
				-121.555628 °	-121.555628 °
DWR ID					
Comment Code					
Inspector Comment					
FS_ID:44404 DS_ID:21139 EP_NO: 653 Repair Type: Non-Urgent Crossing Status: Found UCIP Comments: Dense vegetation on landward side limits visual inspection of potential leaks. Recommend clearing slope of vegetation. FIELD_STRUCT_DESC: 16-inch steel irrigation pipe through the levee, 14.3 feet below the crown. Pump on the landside (LS). Gate valve on the waterside (WS) slope. (16-inch pipe authorized under Permit No. 653, 1935-E. G. Elliott) [Additional Reference(s): DWR Levee Logs, 2005. USACE Sacramento O&M Manual Unit No. 114, April 1959, River Mile (RM) 50.29] FS Date: 5/14/2013

Pipe section visible at waterward toe.

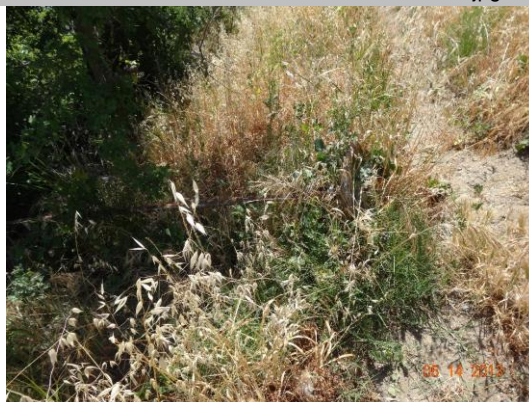
Photo 2 of 3 : UCIP_SP_2018_44404_60818.jpg

View of waterward side--dense vegetation limits inspection.

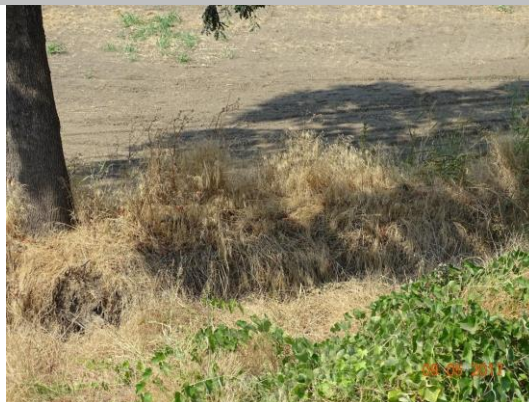
Photo 1 of 2 : SP_2018_RD0765_211_51_20180301_00059.jpg

Looking northwest at the irrigation ditch on the landside toe.

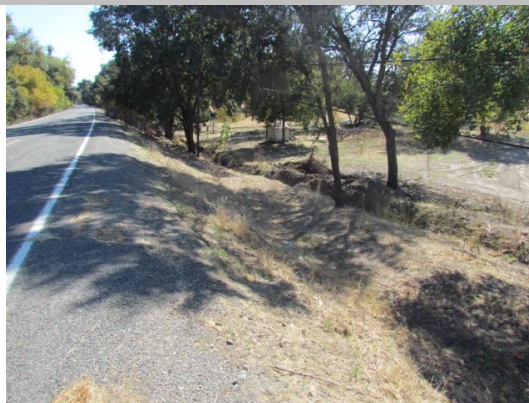
Photo 2 of 2 : SP_2018_RD0765_211_51_20180301_00060.jpg

Looking southwest at irrigation ditch on landward toe.

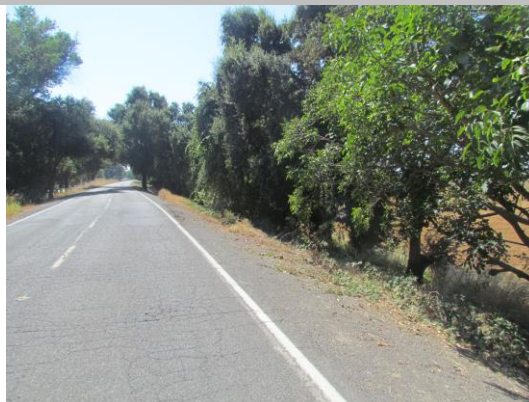
Photo 1 of 1 : SP_2018_RD0765_211_38_20180301_00045.jpg

Looking southwest at untrimmed trees on landward slope.

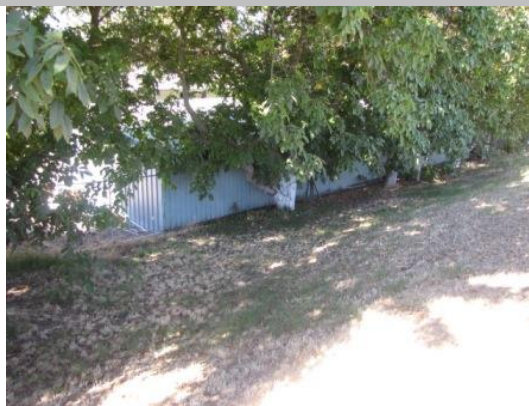
Photo 1 of 1 : SP_2018_RD0765_211_43_20180301_00049.jpg

Looking northwest at buildings along landside toe.

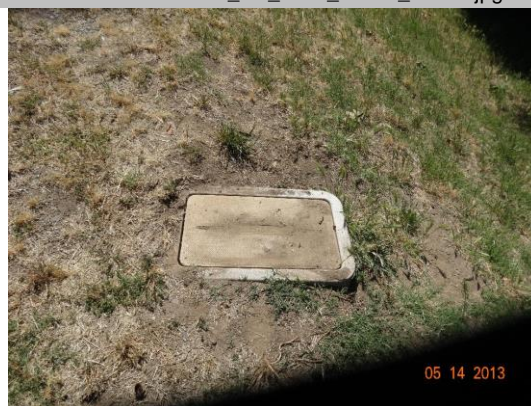
Photo 1 of 2 : UCIP_SP_2018_43203_71214.jpg

LM Start	1.20	Rating **	M	Issue No.	72
LM End	1.20	Issue Type +	En	Location *	
Category	Supplemental			GPS Latitude/Longitude	
				Start	End
Item	DWR UCIP Field Study			38.486830 °	38.486830 °
				-121.553698 °	-121.553698 °
DWR ID					
Comment Code					
Inspector Comment					
FS_ID:43203 DS_ID:24660 EP_NO: N/A Repair Type: Non-Urgent Crossing Status: Indicator Found UCIP Comments: Unable to confirm details of crossing. Need to contact owner to determine additional details about crossing and permit issued. FIELD_STRUCT_DESC: PG&E utility service box located on the landside shoulder. FS Date: 5/14/2013

Utility box located on landward side.

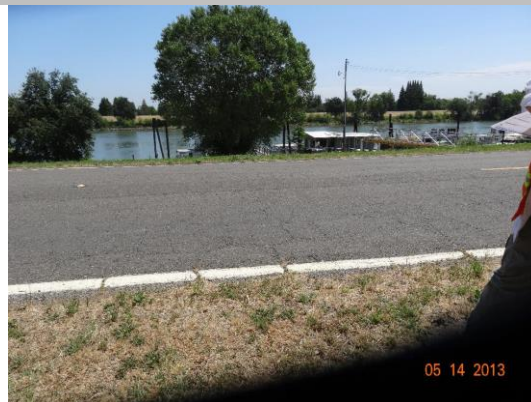
Photo 2 of 2 : UCIP_SP_2018_43203_71213.jpg

View of levee crown and waterward side.

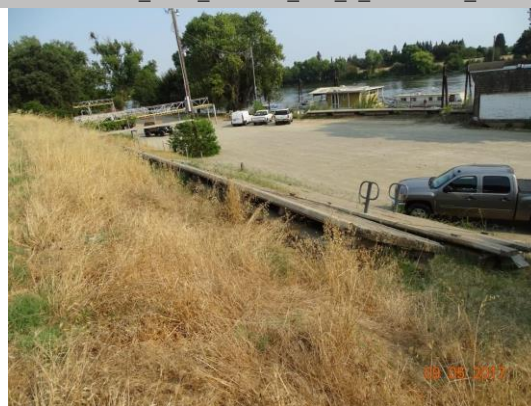
Photo 1 of 1 : SP_2018_RD0765_211_2_20180301_00002.jpg

Looking north at the waterside slope.

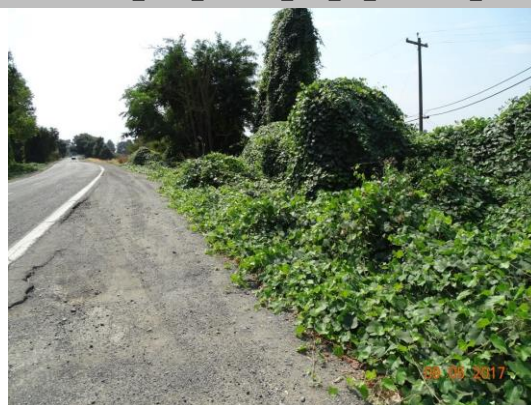
Photo 1 of 3 : SP_2018_RD0765_211_33_20180301_00040.jpg

Looking south at the landside slope.

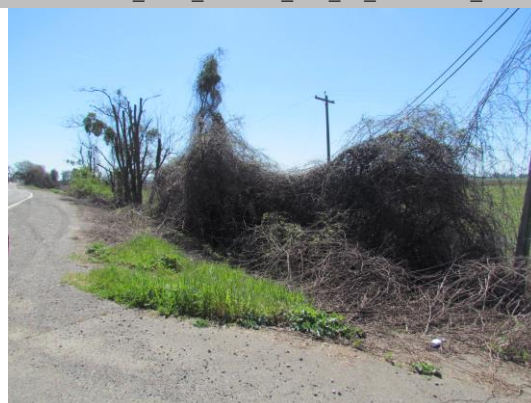
Photo 2 of 3 : SP_2018_RD0765_211_33_20180301_00041.jpg

Looking west at dead vines on landward slope. (Spring 2017)

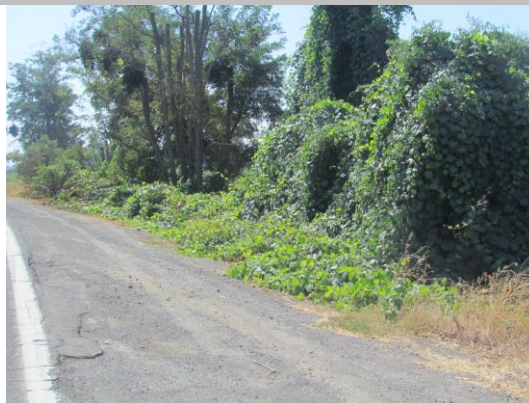
Photo 3 of 3 : SP_2018_RD0765_211_33_20180301_00042.jpg

Looking west at dense vegetation (grapevines) on landward slope. (Fall 2016)

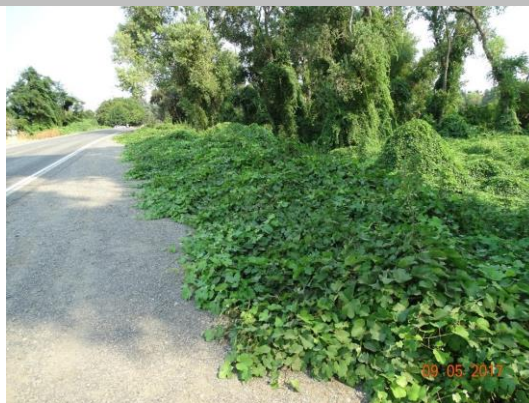
Photo 1 of 1 : SP_2018_RD0765_211_56_20180301_00066.jpg

Looking northwest at waterside slope.

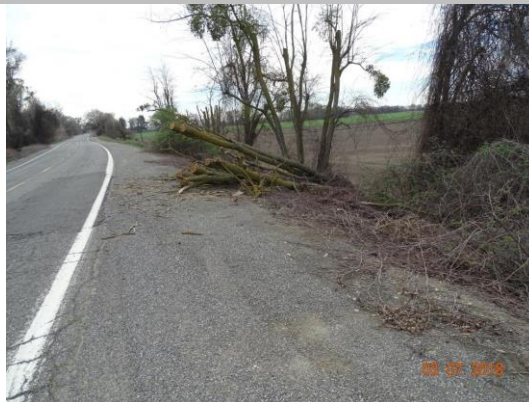
Photo 1 of 1 : SP_2018_RD0765_211_26_20180308_00095.jpg

Encroachment downed tree landside looking south.

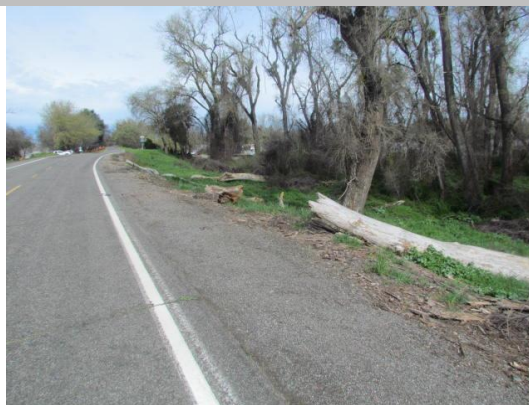
Photo 2 of 4 : SP_2018_RD0765_211_7_20180301_00011.jpg

Looking northeast at tree limbs on waterward slope.

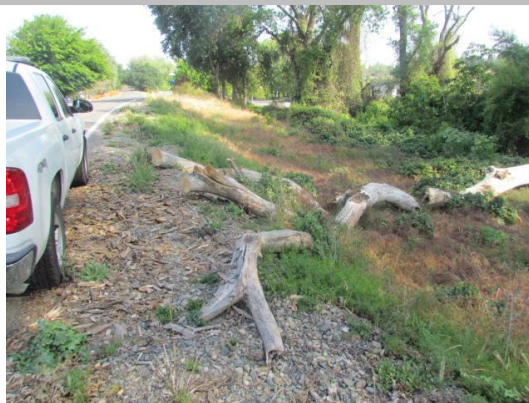
Photo 4 of 4 : SP_2018_RD0765_211_7_20180301_00013.jpg

Looking north at down tree across waterward slope.(2015)

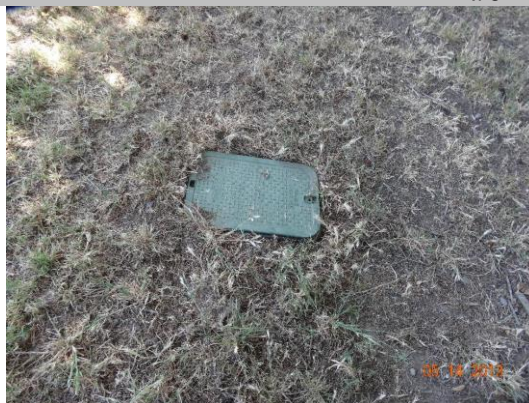
Photo 1 of 1 : UCIP_SP_2018_39022_71212.jpg

Utility box located on landward shoulder.

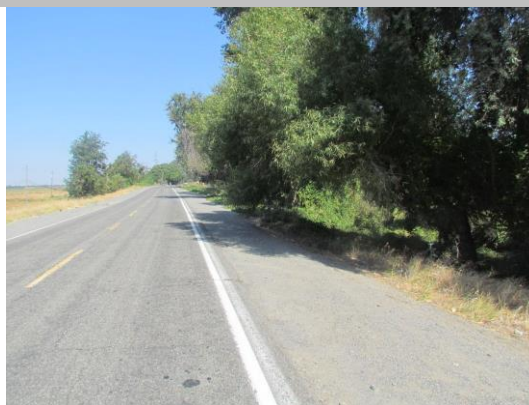
Photo 2 of 3 : SP_2018_RD0765_211_4_20180301_00007.jpg

Looking northeast at untrimmed trees on waterward slope. (Spring 2016)

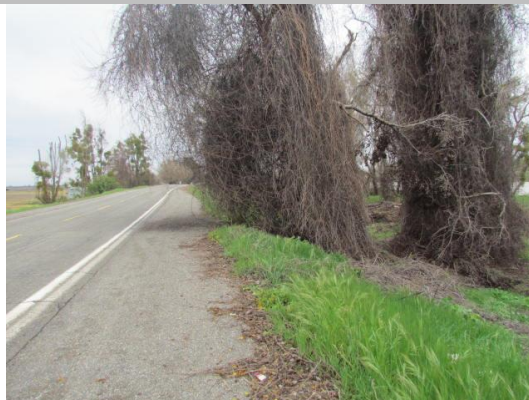
Photo 3 of 3 : SP_2018_RD0765_211_4_20180301_00008.jpg

Looking north at untrimmed trees on waterward slope. (Spring 2016)

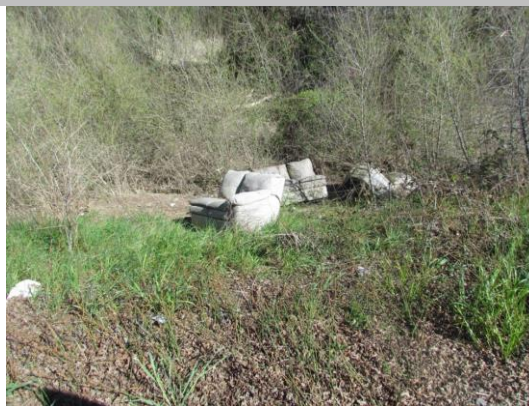
Photo 1 of 2 : SP_2018_RD0765_211_67_20180301_00077.jpg

Looking east at sofa on waterward slope.

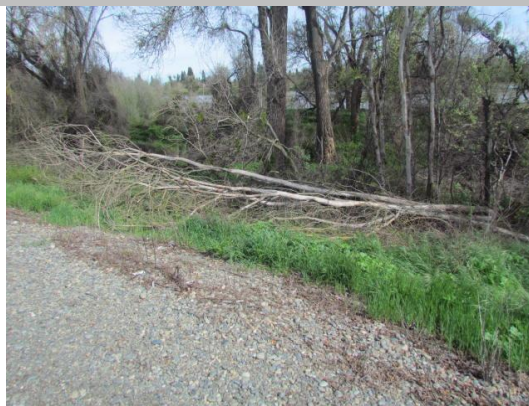
Photo 1 of 1 : SP_2018_RD0765_211_64_20180301_00075.jpg

Looking at fallen tree on waterward slope and toe.

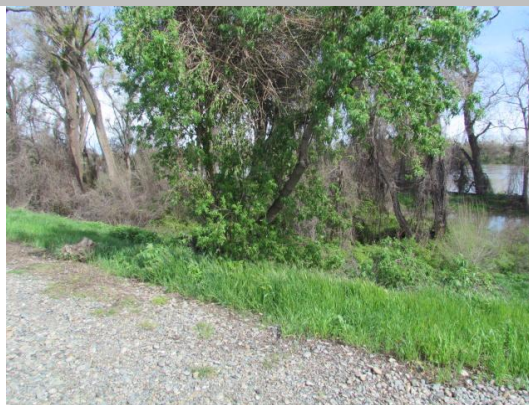
Photo 2 of 2 : SP_2018_RD0765_211_50_20180301_00058.jpg

Looking east at untrimmed tree on waterward slope.

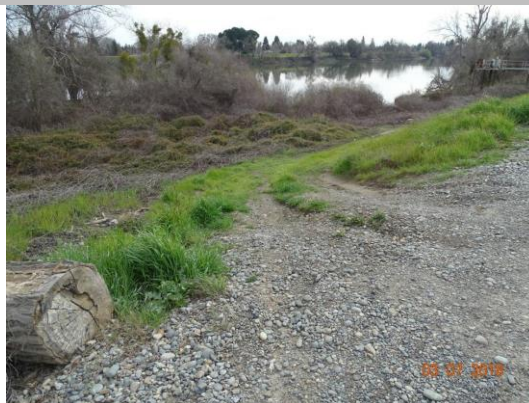
Photo 1 of 1 : SP_2018_RD0765_211_31_20180308_00092.jpg

Slope stability waterside looking southeast.

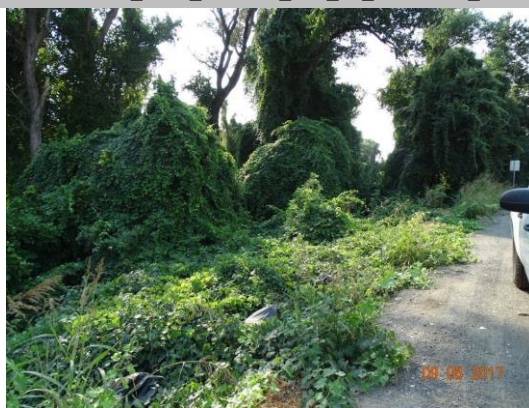
Photo 1 of 2 : SP_2018_RD0765_211_25_20180301_00029.jpg

Looking southeast at waterside slope.

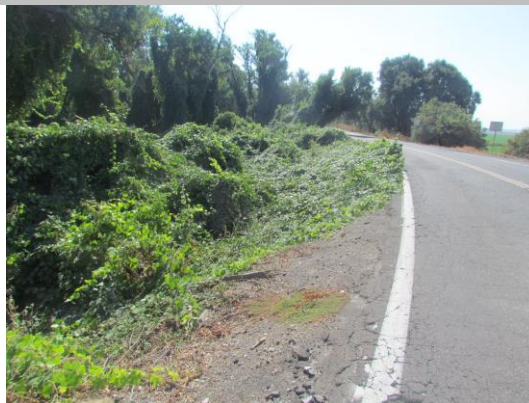
Photo 2 of 2 : SP_2018_RD0765_211_25_20180301_00030.jpg

Looking south on at dense berryvines on waterward slope.

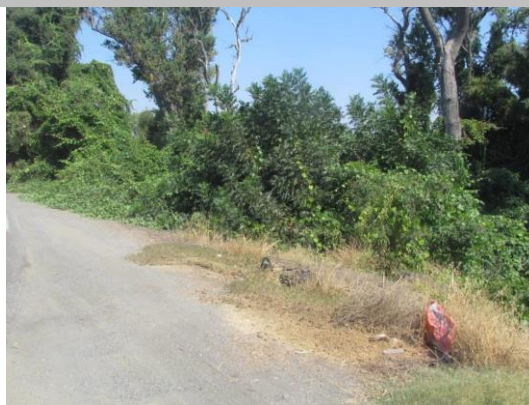
Photo 2 of 2 : SP_2018_RD0765_211_53_20180301_00062.jpg

Looking north at dense vegetation on waterward slope. (Fall 2016)
